Tovu Fresh Water System

Taylor Broussard
The Honor Journey

TOVU FRESH WATER SYSTEM

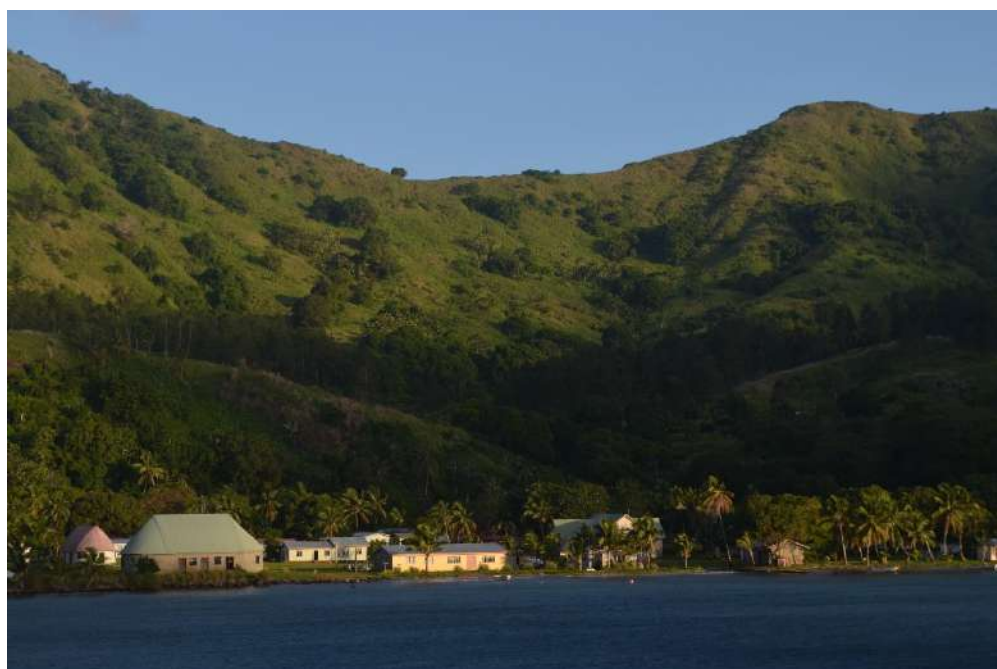
Figure 1 Tovu Village

The target community for this project is Tovu in Totoya Island shown in Figure 1. It is the chiefly village also known as Dawaleka. The Paramount Chief of Totoya is known as the Gone Turaga na Roko Sau. This title is currently held by Roko Josefa Cinavilakeba.

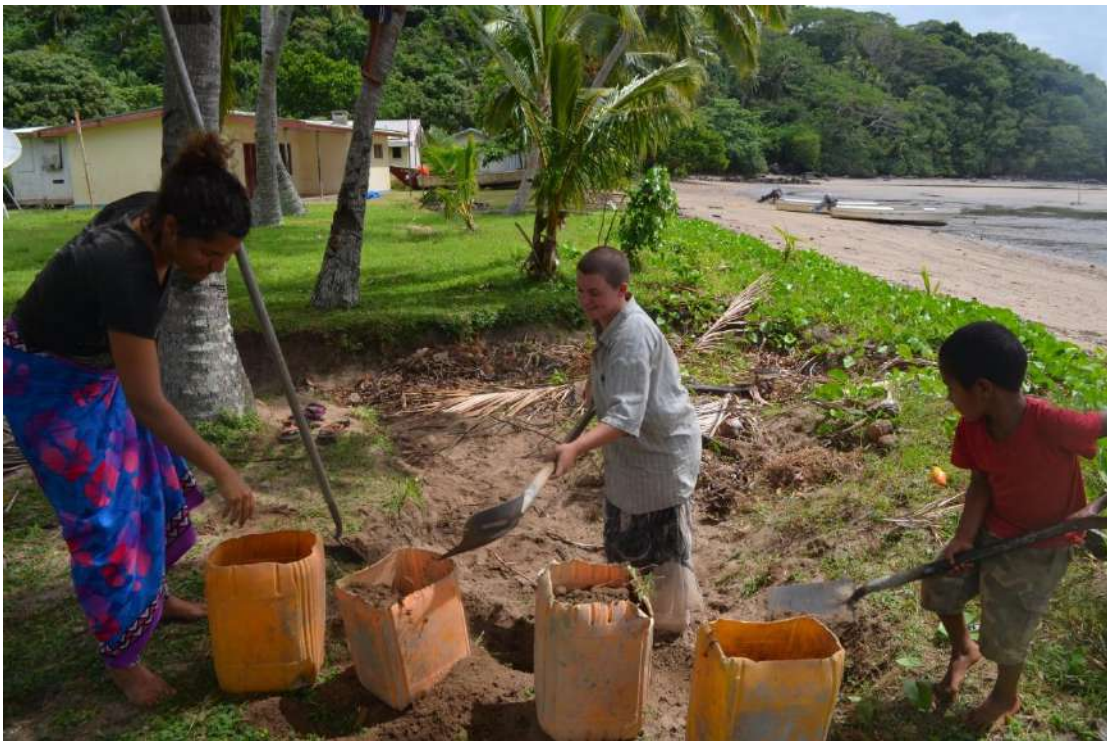
Figure 6 Sand Collection

All of the materials were delivered to the Lomaiviti Princess II ferry at the Narayan Jetty. The Honor Journey Team boarded the ferry in Suva on November 6, 2018. The team and the materials arrived in Tovu on November 7, 2018. After becoming acclimated to the community and having a day of rest, the team began carrying materials up to the job site. Originally, Roko Sau had requested the water project be built at the cement tank site that was at the top of the community. After speaking with the community and with Roko Sau, it was understood that the tank in that location would only serve a few houses and was fed from an unreliable stream source. The decision was made to install the plastic water tanks at the cement tank site that is located a lower point in the community and fed from a reliable spring source. The next step was to begin collecting sand from the beach, this activity is shown Figure 6. It was observed that this practice puts the community in danger from storm surge, rising sea levels, and coastal erosion. It is recommended that for future construction projects, sand should be purchased from a Quarry or collected from a source that does not put the village at risk. On November 12, the team constructed the mold for the foundation and began leveling the site. The site was leveled with shovels and a water level.

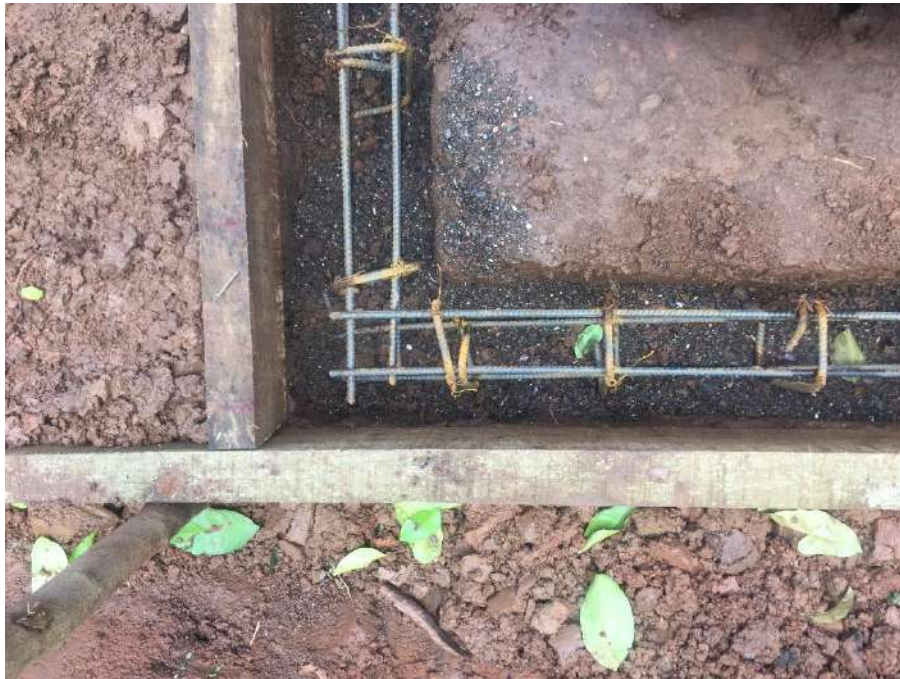
Figure 7 Rebar Placed on Compacted Gravel

Next the perimeter edges of the tank floor were dug to a depth of 400mm. Large stone was collected from the community creek and small gravel was collected from the beach in the nearby community Ketei. This was a very laborious task and required a lot of man and woman power! After the perimeter was dug, large stones were laid down and smaller gravel was compacted around it to a height of 200mm. Compacted gravel was not used on the thickened portion of the slab due to lack of material and time. It was decided that the team did not have the adequate resources or skill to bend the rebar into the rings specified in the design. Instead, the team decided to bend simple stirrups around 4 longitudinal bars, two on top, two on bottom. The rebar stirrups are shown in Figure 7 and Figure 8 Rebar Stirrups.

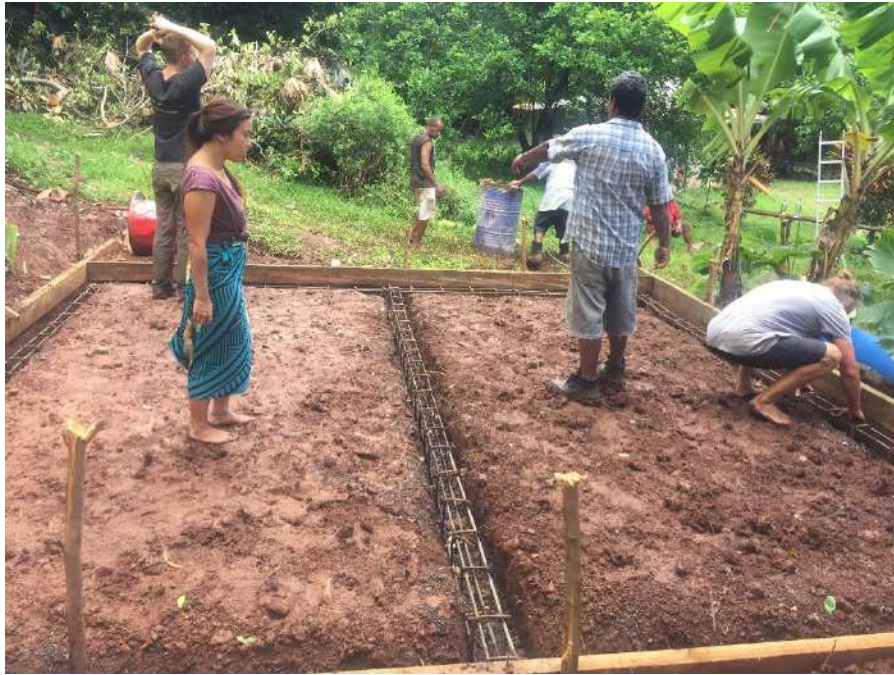
Figure 9 Thickened Sections

A mistake was made while cutting the stirrup lengths, instead of cutting 1 m segments of the long bars, multiple long bars were completely cut into small segments. This reduced the amount of longitudinal bars available. Four bars of rebar approximately 4 m long were taken from an ongoing church construction site. Due to this restriction in material it was decided that only one thickening would run through the center of the slab instead of two as the design called for. The reinforcement for the 5 thickened sides of the slabs were placed with small stones. This layout can be seen in Figure 9.

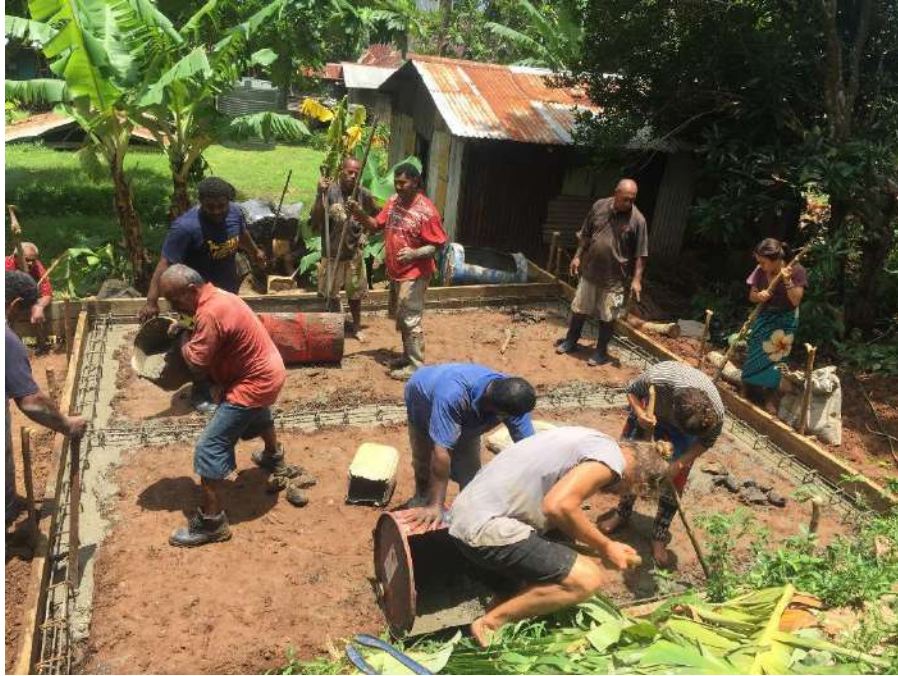
Figure 10 Pouring Cement

On November 15 the team prepared the mix and poured the cement for the slab. Figure 10 is a photo of the team pouring cement. The thickened portions were poured first. After they were finished with the thickened portions, the team took a one-hour lunch break. This resulted in an un-uniform pour of the slab.

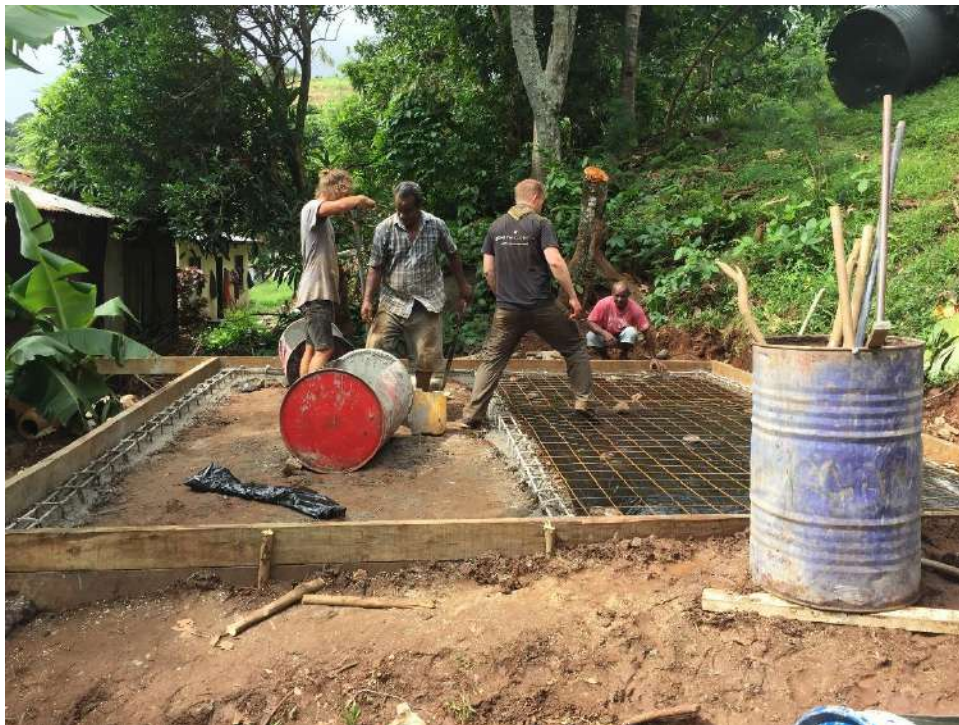
Figure 11 Installation of Plastic Membrane and Mesh Wire

The plastic membrane was placed on the foundation floor. As shown in Figure 11, one layer of wire mesh was seated on top of the membrane with small stones.

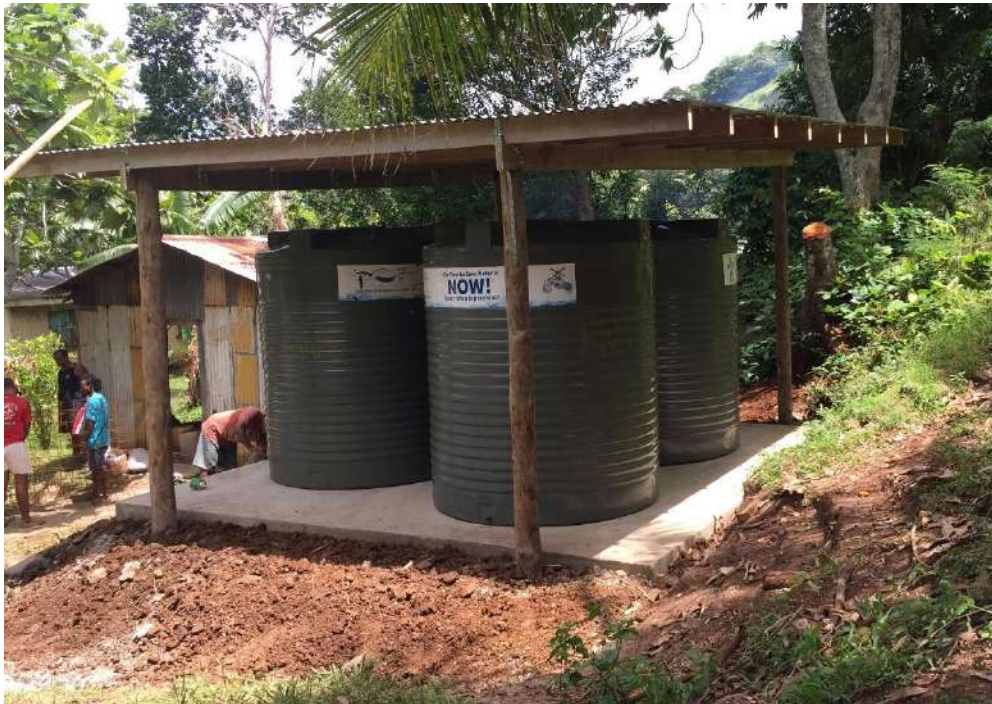
Figure 13 Finished Product

The roof structure was installed on November 20th and the tanks were placed on the slab. Due to the lack of time, the plumbing for the tanks was not initiated. The last progress reached on the 2018 Honor Journey Team trip to Tovu is shown in Figure 13. An inventory of leftover materials was recorded and is presented in **Error! Reference source not found.** In addition, Seni Rusi requested a list of plumbing materials to install the tanks properly.
